# **Exhibit E – Consultant Reports**

DSA 103.....	3-20
Hazardous Materials Survey.....	21-96
Geotechnical Report.....	97-191

**GEOTECHNICAL MAP**  
 Proposed Transportation Office Expansion  
 Corona-Norco Unified School District  
 300 South Buena Vista Avenue, Corona, California

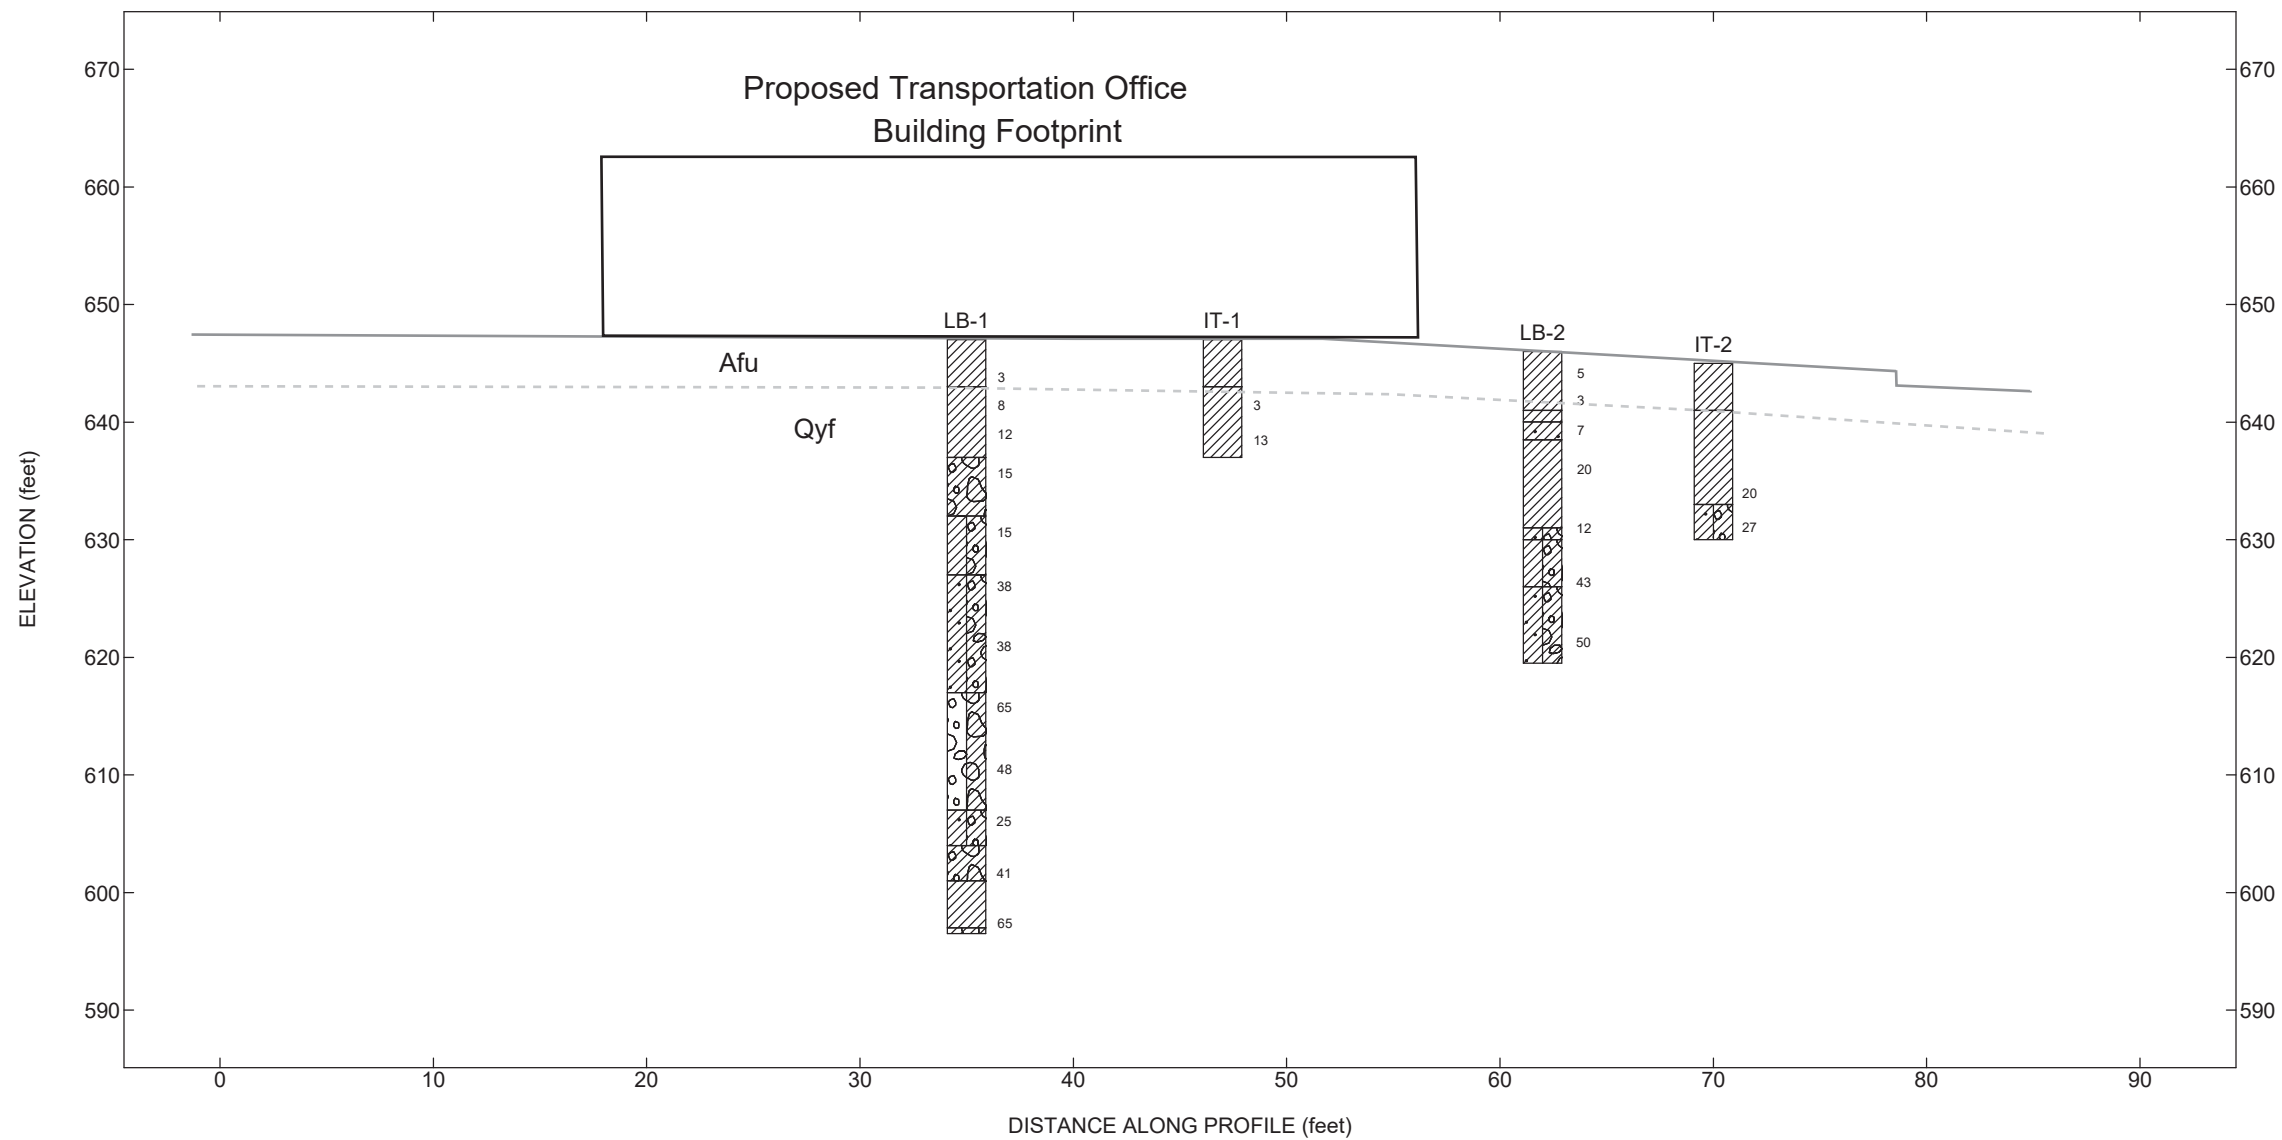
JOB NUMBER	FIGURE NUMBER
13847.001	Figure 4A

See Figure 2 for Cross-Section Location

More detailed descriptions of the subsurface conditions are presented on the boring logs in Appendix A. Cross-sectional illustrations of encountered subsurface soil conditions are included as Figures 4A and 4B.

7. <b>Geologic Cross Sections:</b> Two or more detailed geologic sections with pertinent foundations and site grading.	Figure 4a; Figure 4b
8. <b>Active Faulting &amp; Coseismic Deformation Across Site:</b> Show proposed structures in relation to Alquist-Priolo Earthquake Fault Zones and/or any potential fault rupture hazard identified from the Safety Element of the local agency (city or county); show location of fault investigation trenches; 50-foot setbacks perpendicular from fault plane and proposed building footprints.	Sec. 2.5.1

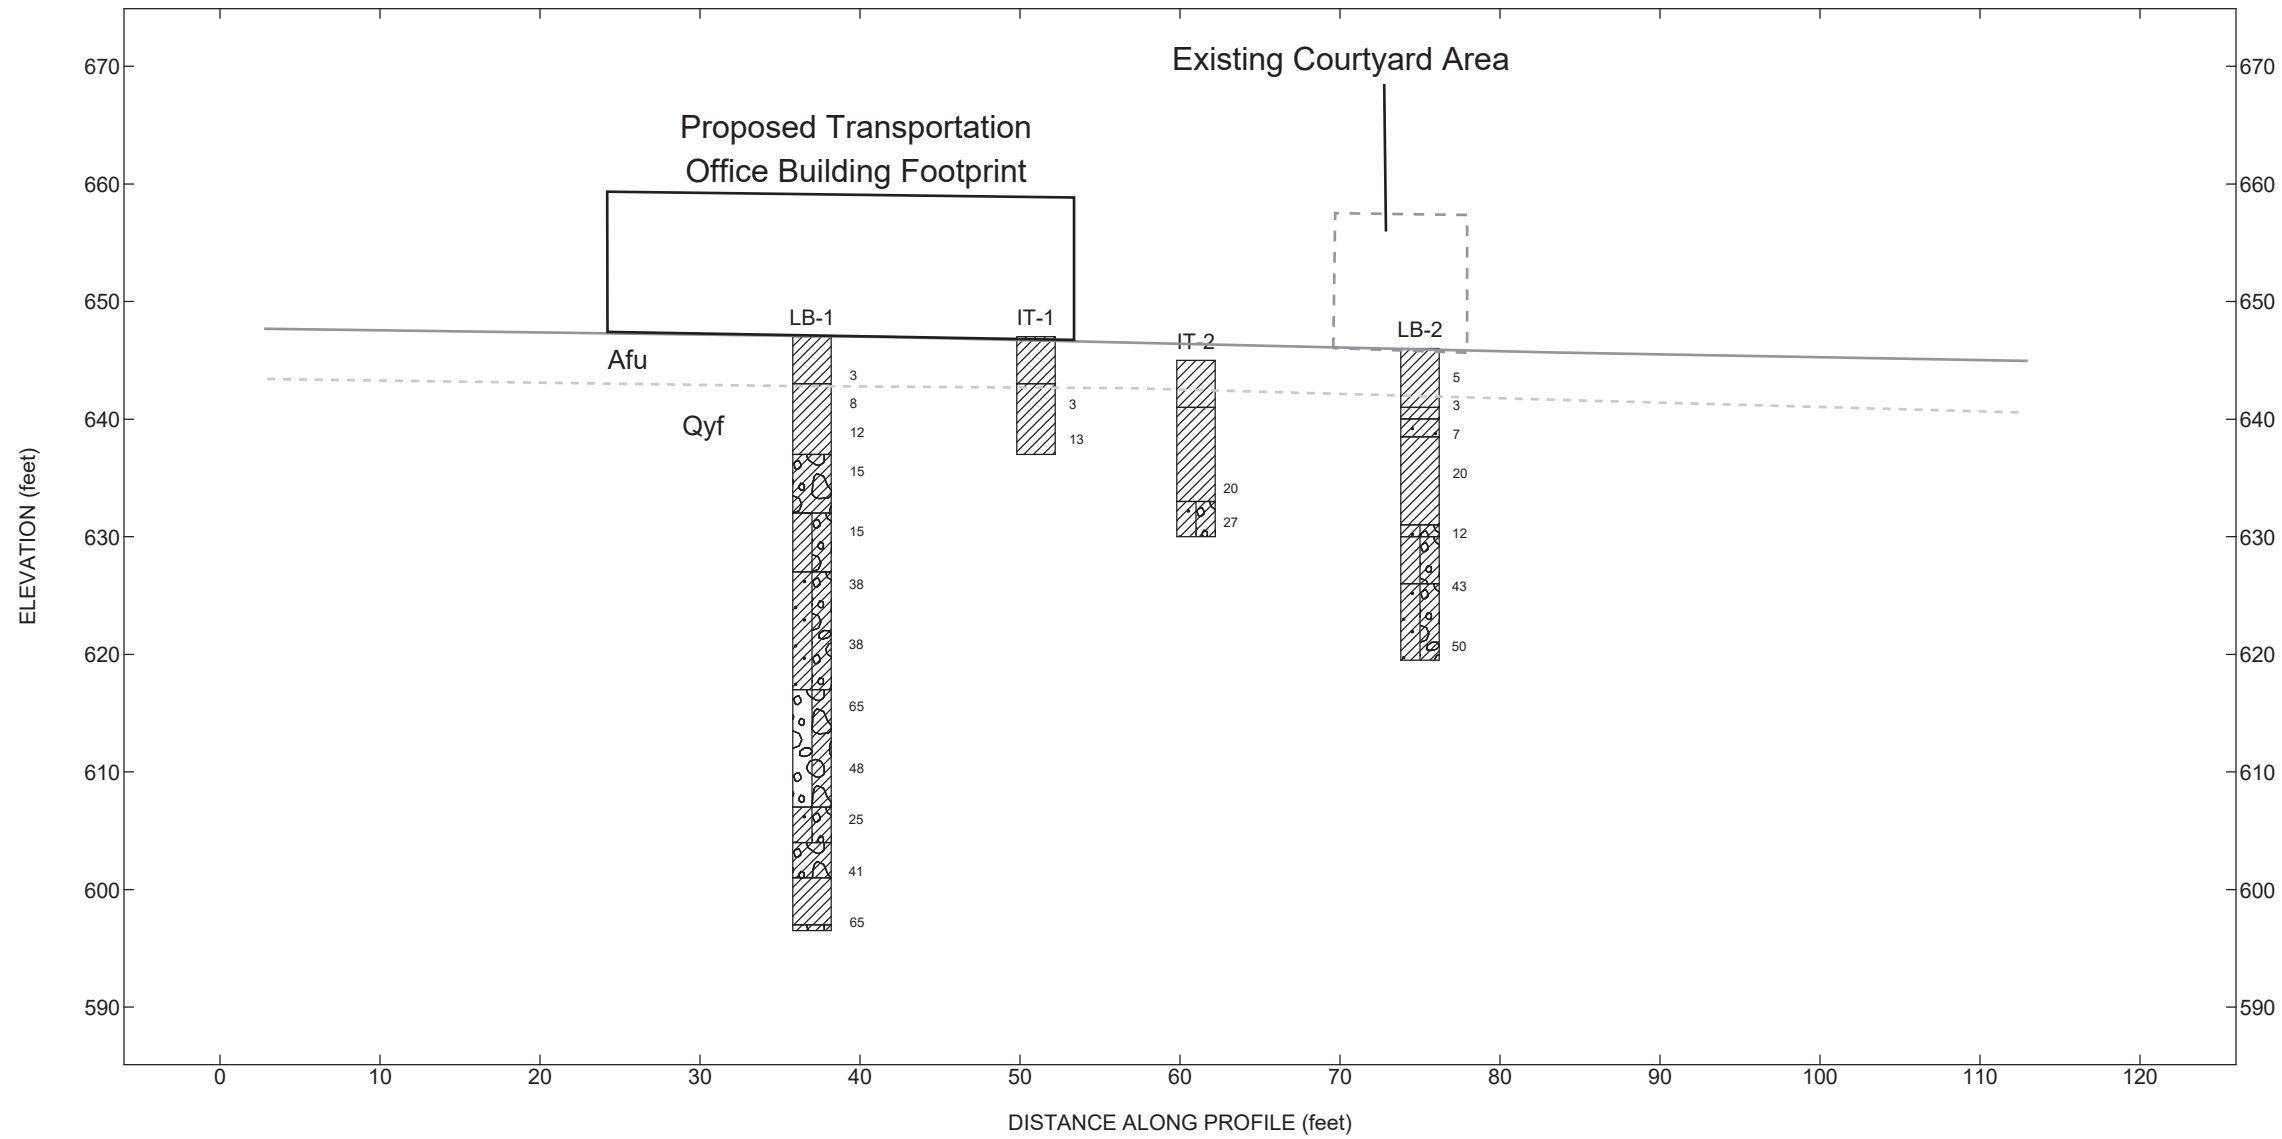
JOB NUMBER	FIGURE NUMBER
13847.001	Figure 4B

See Figure 2 for Cross-Section Location

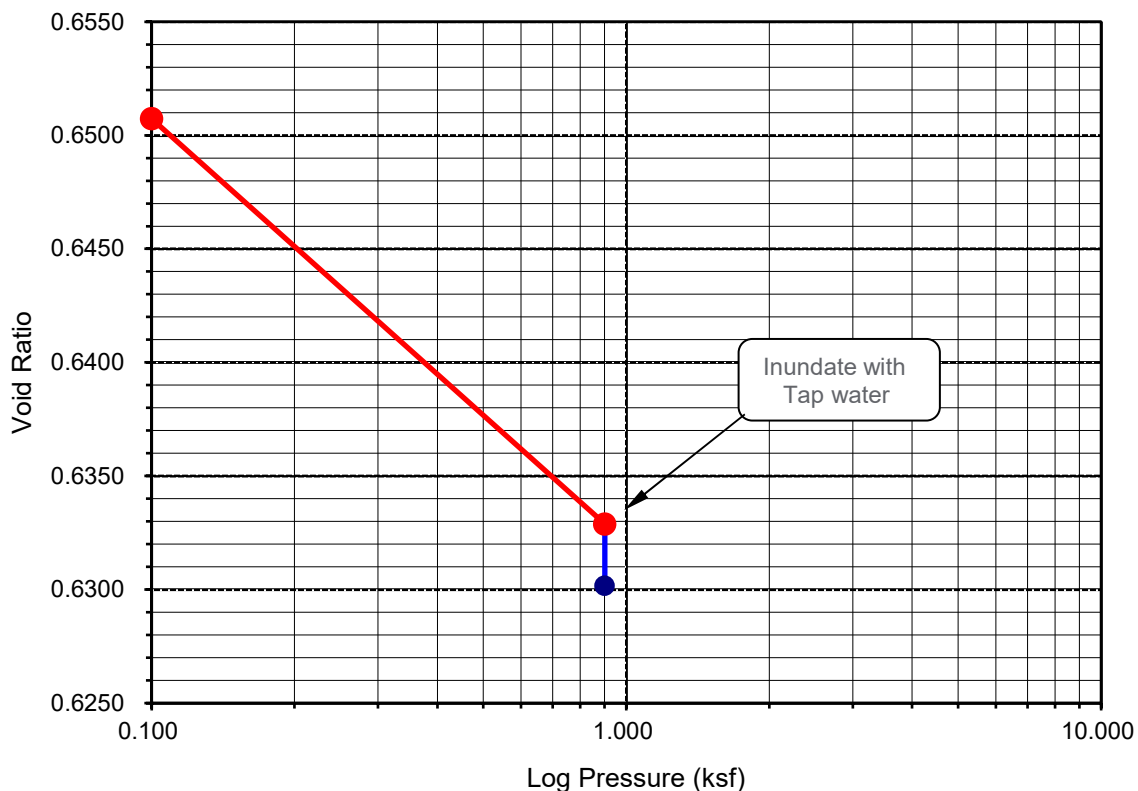
**Void Ratio - Log Pressure Curve**

**EXPANSION INDEX of SOILS**  
ASTM D 4829

**Percent Swell (+) / Settlement (-) After Inundation = -0.17**
